# Catchment Update Summer 2016

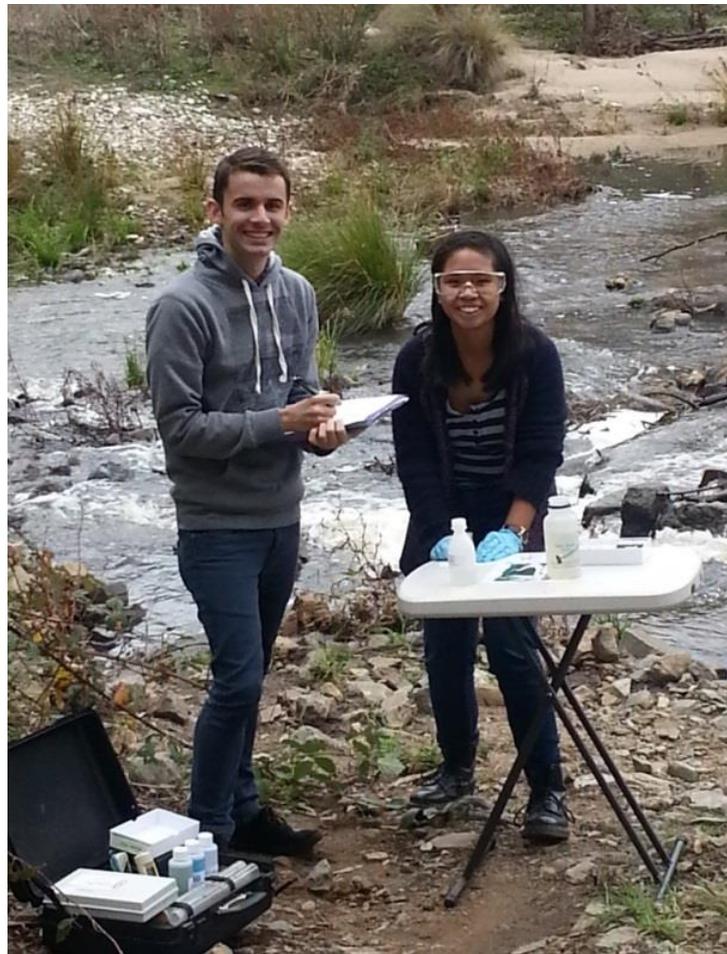
Danica found the Naas River dry by the time it got to Caloola Farm for most of summer. Near the national park the water was still flowing. The little Gudgenby creek still had water in it too but it was salty, full of phosphorus and, of course, cows.

**Danica with friend Michael at Waterwatch training last year. The river site behind them was dry this summer.**

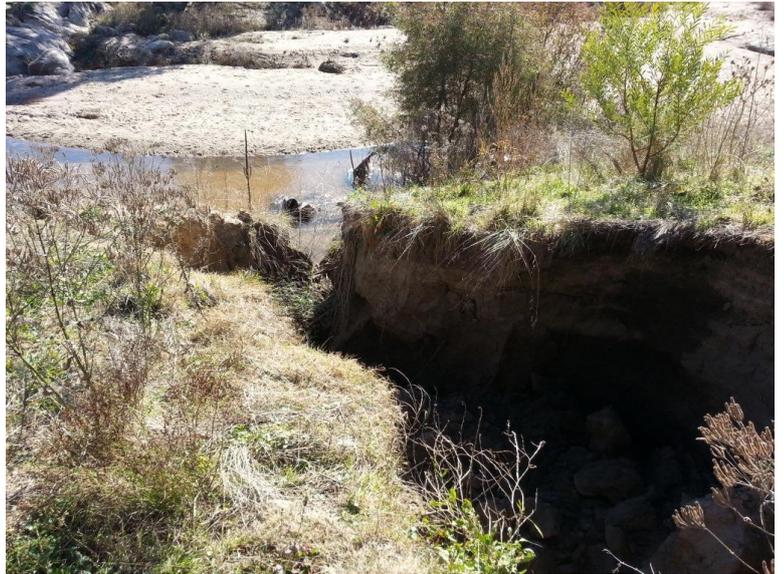
The pH bordered on high up near the confluence with the Naas River, but downstream a major concern in this reach was the continued bank erosion near the Smiths' Road that appeared after the new bridge went in. Deb from the Parkcarers of Southern Murrumbidgee (POSM) who monitors a site adjacent to the bridge took this issue as far as the Minister to finally get a positive outcome.

**Gudgenby Canyon before erosion control work**

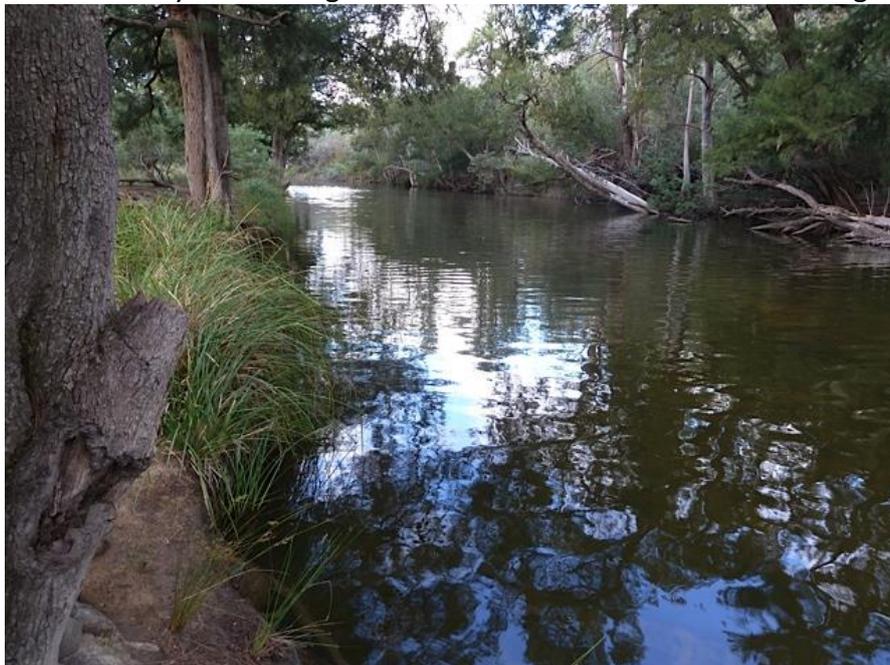
Fleur and Maree found the water levels low but clear at the campground for most of summer with a some refill happening by their February monitoring. Blackberries were noted as a re-emerging problem.

**Cotter River at the campground this summer. Photo Fleur Horan**

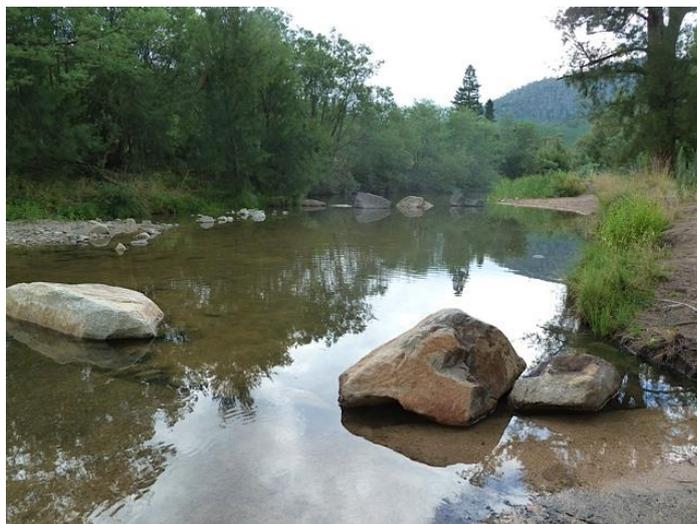
Paddy's River was clear but very low in early summer. Heavy showers in Later December moved a lot of sediment that was detected by PCS Ranger Bernie at Flint's Crossing in January. Sand and gravel were moved around by the increased flow but this all settled down and by the end of February Fleur and Maree noted very little increase in water levels, just lots of gravel and weeds.

**Murray's Corner this summer Photo Fleur Horan**

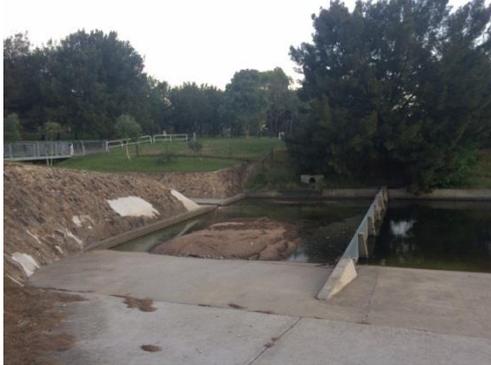
High sediment built up in one of the northern GPTs of the lake was reported by Ben and the RTA mobilised to get it cleaned. Lake Tuggeranong College have once again resumed their Waterwatch monitoring and had their kit returned by the Lake Tuggeranong Rowing Club who thankfully held the reigns while Nikey was forced to pause LTC Sustainability unit. Thanks to Lyndon and Bob.

**FWanniassa Creek GPT Photo Ben Bryant**
