Catchment Update

Autumn 2013

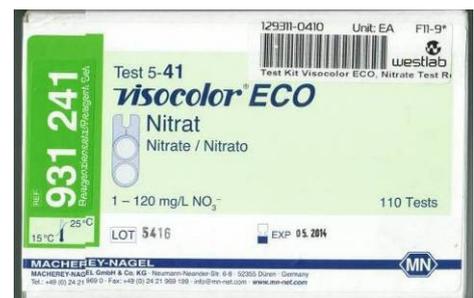
Nitrates and Nitrites: We are now moving to a new test for Nitrates. Many groups have ceased using the Quantofix test strips and have been issued the new Visocolor kits (see photo). If you don't have one yet don't panic. I will be chasing you soon. Nitrites will no longer form part of our testing and will be dropped from the data base and record sheets soon. Schools will continue to use the old strips so please do not throw them out. No readings of concern were recorded. In fact, the new tests are revealing much lower levels of nitrates than were indicated by the strips. This makes sense as the strips simply gave a choice between 0 or 10 for low readings whereas the new test covers low values more accurately.

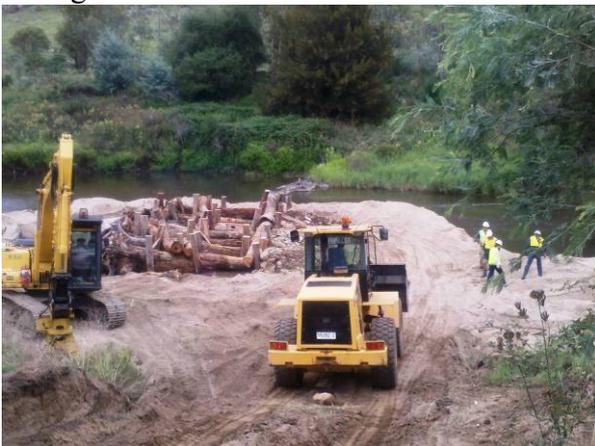
The Engineered Log Jam project was completed this season as 4 enormous rock 'groins' were installed just downstream of Tharwa Bridge. They are quite visible as you drive over the bridge. The aim is to drive the sand built up in that part of the river, down stream using increased water velocity and eddying caused by the structures. They already seem to be working as a nice trench of deep water has appeared between them. The long term aim of these is to improve habitat and passage for native fish, which have not coped well with the shallow sandy river beds that have appeared in the slower reaches of the Murrumbidgee. Waterwatch monitoring by **Rhonda** of Cuppacumbalong, at the site showed no negative affect on the river during the construction works. This is a credit to the careful planning and execution of the project by the Conservation Planning and Research team and their contractors.

Construction underway in late February.

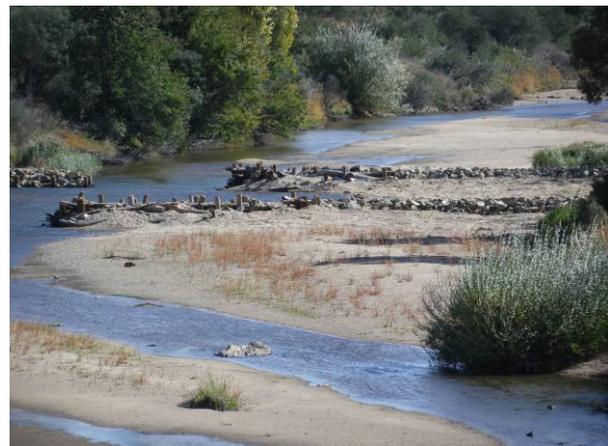
The finished groins in April (Photos courtesy of CPR)

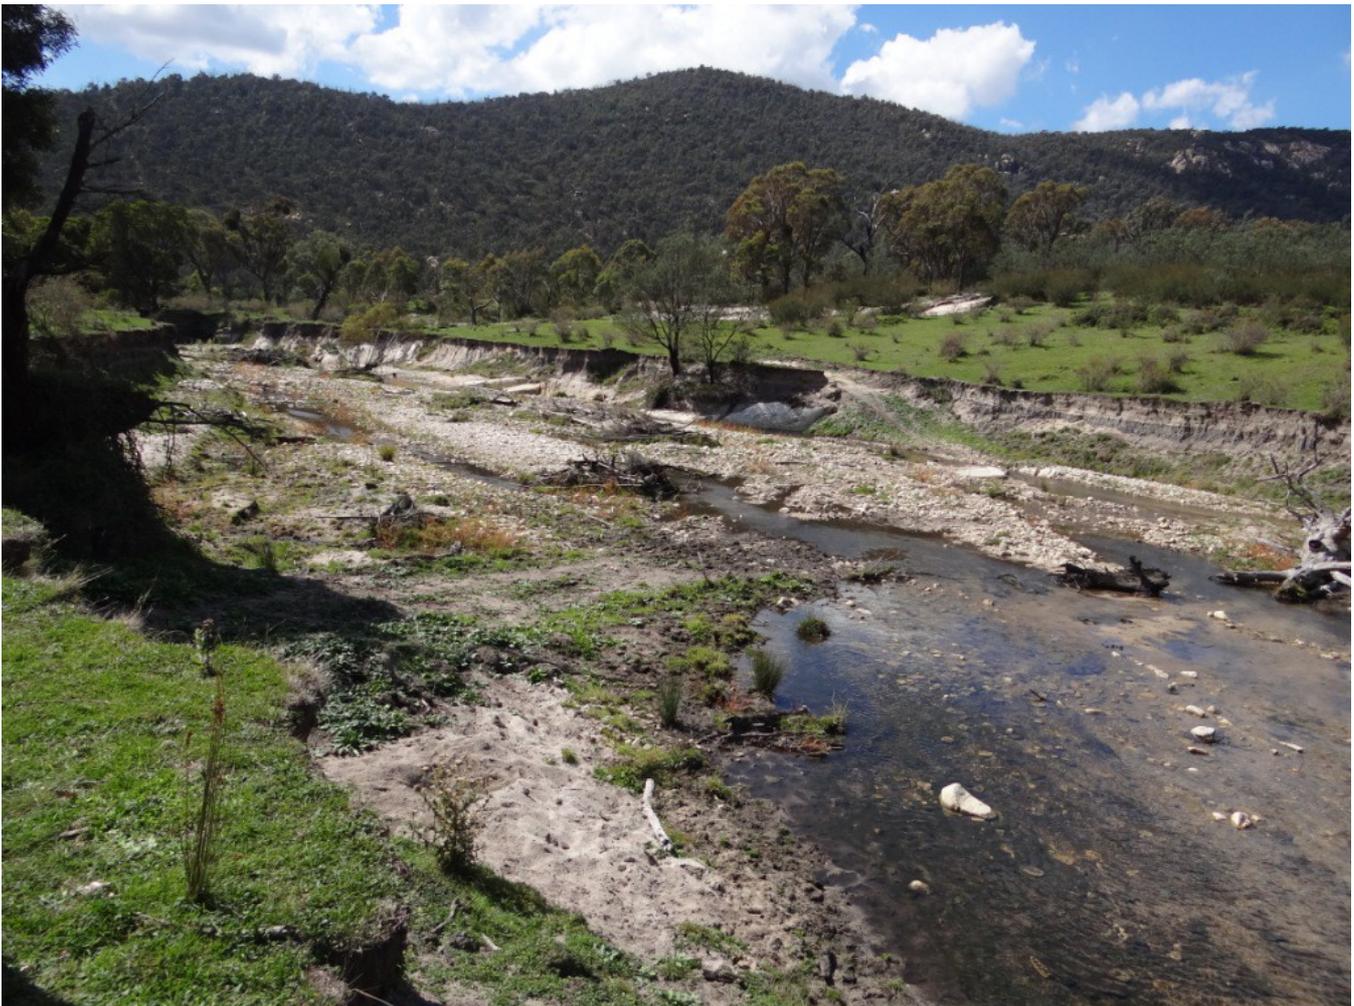
Miranda, Woo and I had the kind acceptance by **Anna and John Hyles** to our request to visit Booroomba Homestead to have a look at the head waters of Paddy's River after some persistently high turbidity readings in the previous months. John showed us an area that had been washed away in March 2012 that covered an area roughly that of a football field. The river bed on his property changed path significantly and the subsequent gouging and soil movement has continued. This is similar to the events south of the ACT that drove huge inflows of mud into the Murrumbidgee. Below is a photo taken by Miranda on the property. That the water looks quite clear matches what Fleur and Maree saw down stream at Murray's Corner. The low seasonal flows fortunately masked the damage done to the surrounding catchment. John has worked in a partnership with Greening Australia and ACTEW's Source Water Protection Program, to fence stock from sensitive sections of the river and restore reaches of other tributaries within his property.

Paddy's River on Booroomba Homestead (Photo: Miranda Gardner)
