# Catchment Update

## In General: Hot. Dry.

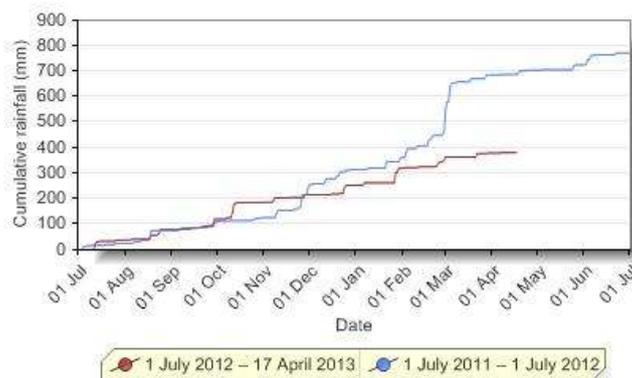
We had the driest summer in six years. Only 142 mm fell over the three months and a third of that fell in one day! (Late January). January was also the hottest on record with an average maximum of 32.3 degrees. Lots of sites recorded drops in water flows and levels. Plants started dying and creek banks became crusty. Then it pored just after Australia day and lots of rubbish got deposited in the gross pollution traps and around the urban ponds and lakes.

Below are the rainfall statistics, courtesy of ActewAGL's website.

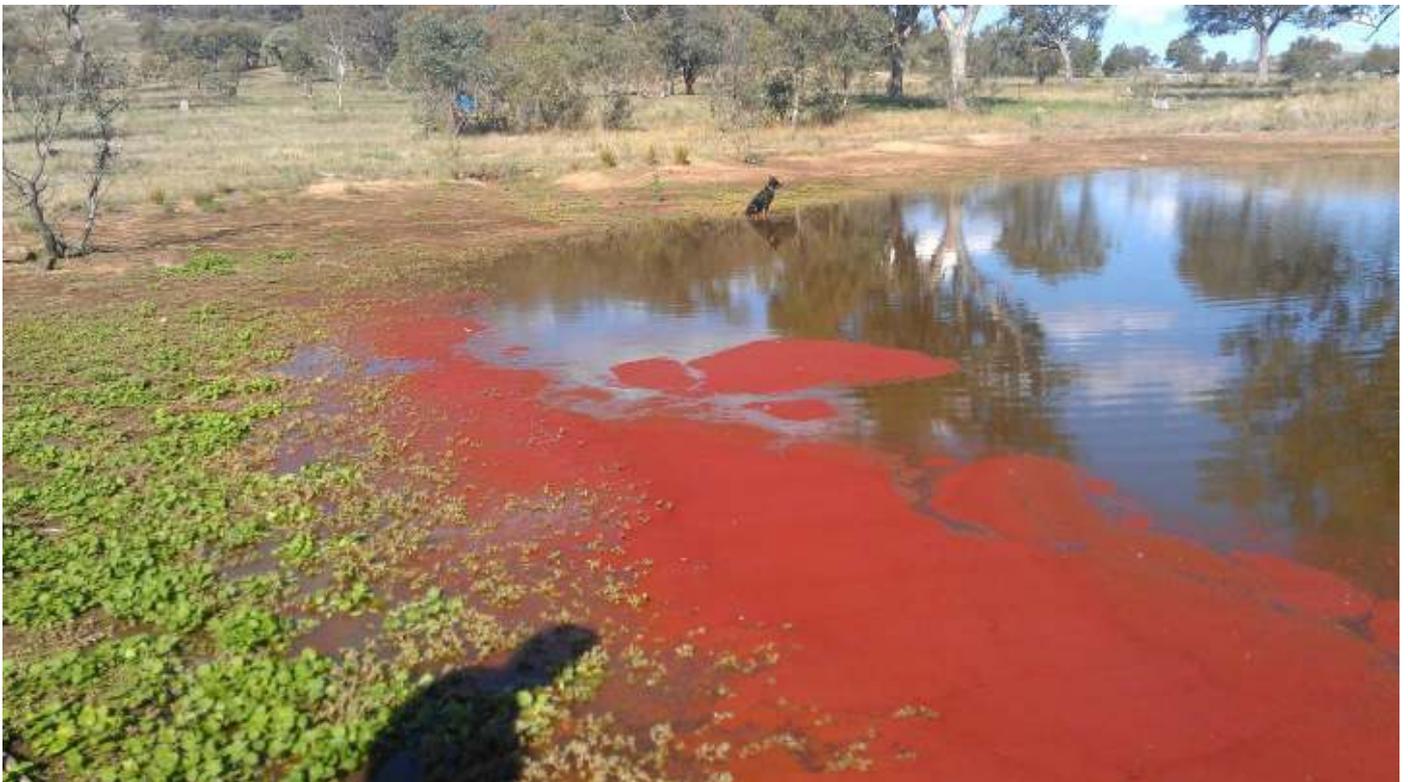
Westwood Farm had an interesting explosion of blood red algae in one of their dams. I'd seen it before in videos of rivers in China. It turns out to be a Euglenoid protozoan that produces the red pigment to protect itself from the sun.

**Euglenoid bloom at Westwood Farm 25.3.13 Photo Wieslaw Lichacz**

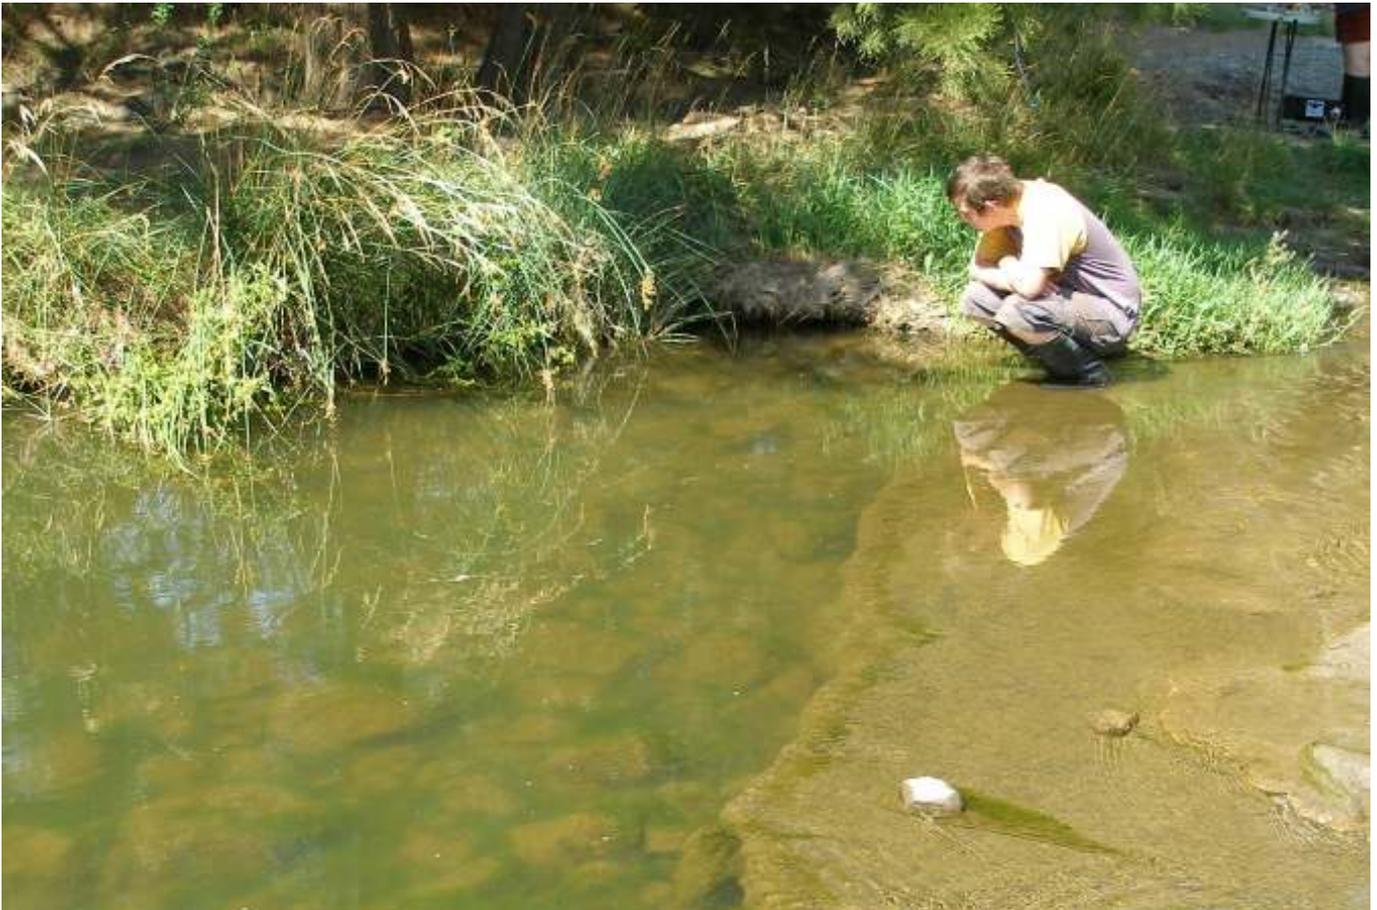
Lake Tuggeranong is not a fan of hot, dry weather. Low flows and warm water combine to give some scary water quality readings. High pH and extremely low oxygen levels were seen a number of times in the south and central parts of the lake. Suspects include low flows over concrete drains and heightened plant (well, algae anyway) activity during the hot sunny days.

**Low flows and lots of algae. Tuggeranong Creek in early January**

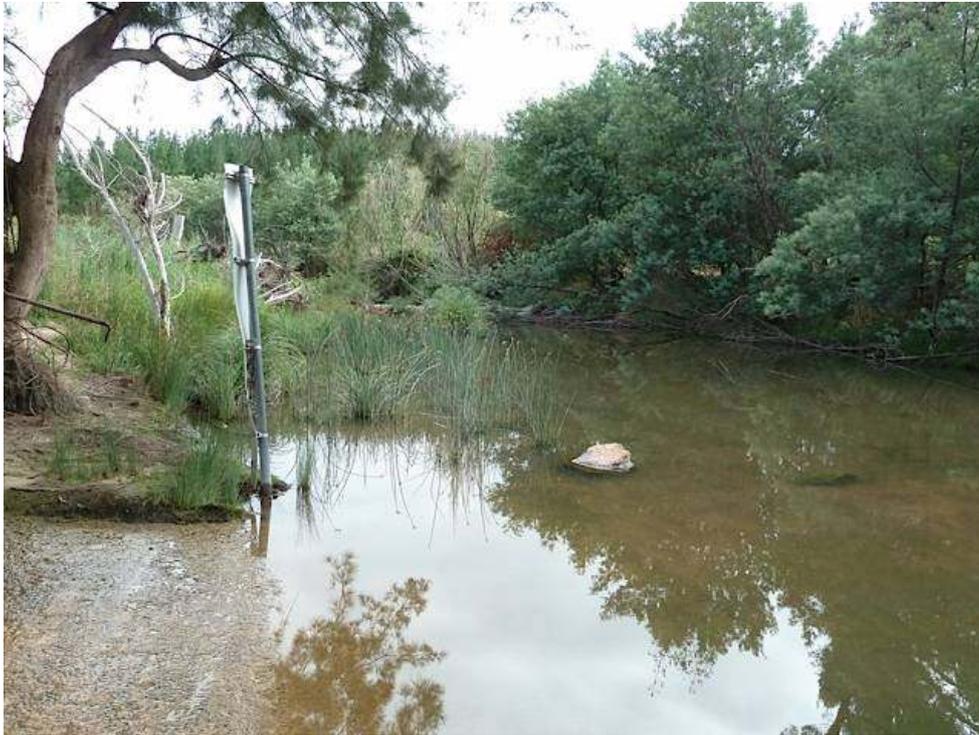
Paddy's River seemed to cop more mud than anywhere else, after the storm on Saturday 26<sup>th</sup>. Miranda's monitoring the next day gave the highest turbidity reading for the season. Maybe it was just luck timing. The Yurung Dhaura team also picked up a huge drop in oxygen and increased turbidity in late summer at Miowera Homestead, which lies between Miranda's site at the Tidbinbilla Road bridge and Murray's Corner on Paddy's River. Murray's Corner was also a bit low in oxygen earlier in January but nothing as drastic. Tidbinbilla Nature Reserve showed the water remaining healthy even through very low flows.

**Murray's Corner in February. Photo Fleur Horan.**

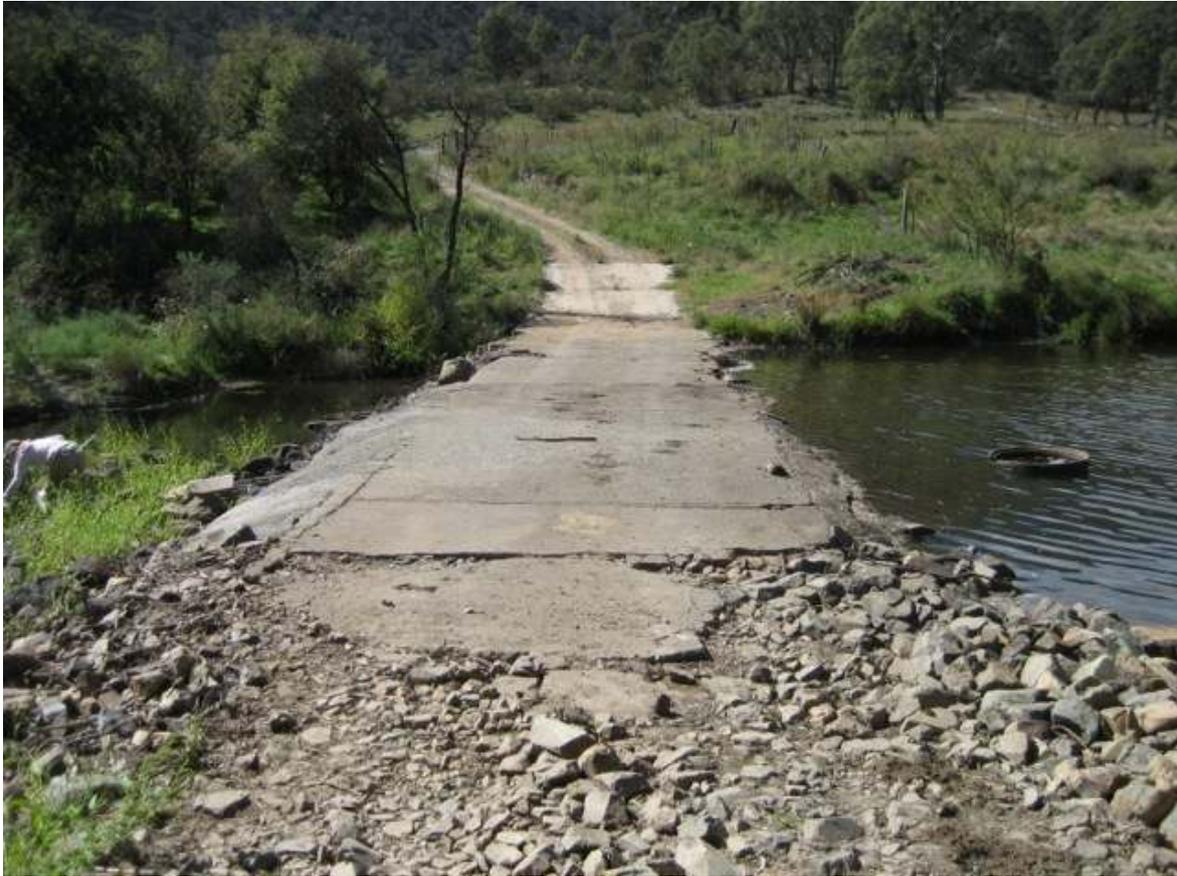
Ian noted in January “Local land owner (Chris) was at the crossing whilst I was testing and informed me that during the recent high temps of 40 degrees the creek had actually stopped flowing. He said the last time that had happened was 10yrs ago during the drought.” The ‘creek’ he is referring to is the Naas River. Both it and the small Gudgenby Creek that Ian monitors, were extremely low. Ian was joined by Uni student Candice in February, who assisted with macro invertebrate surveys at his sites. There was not enough water in Gudgenby Creek to dip a net, so they stirred up what bugs they could in the creek and ‘made a guess’. Never let it be said that our volunteers aren’t resourceful.

Naas River at Caloola Farm in Feb This crossing usually has a good flow over water over it. Photo Ian Long
